LIMITED ASBESTOS SURVEY REPORT

FRANK J. DOYLE SITE

905 N. POPLAR STREET
LEONARD, TEXAS 75452
MEC^X PROJECT NO.: 1303.009E.00

9 October 2018

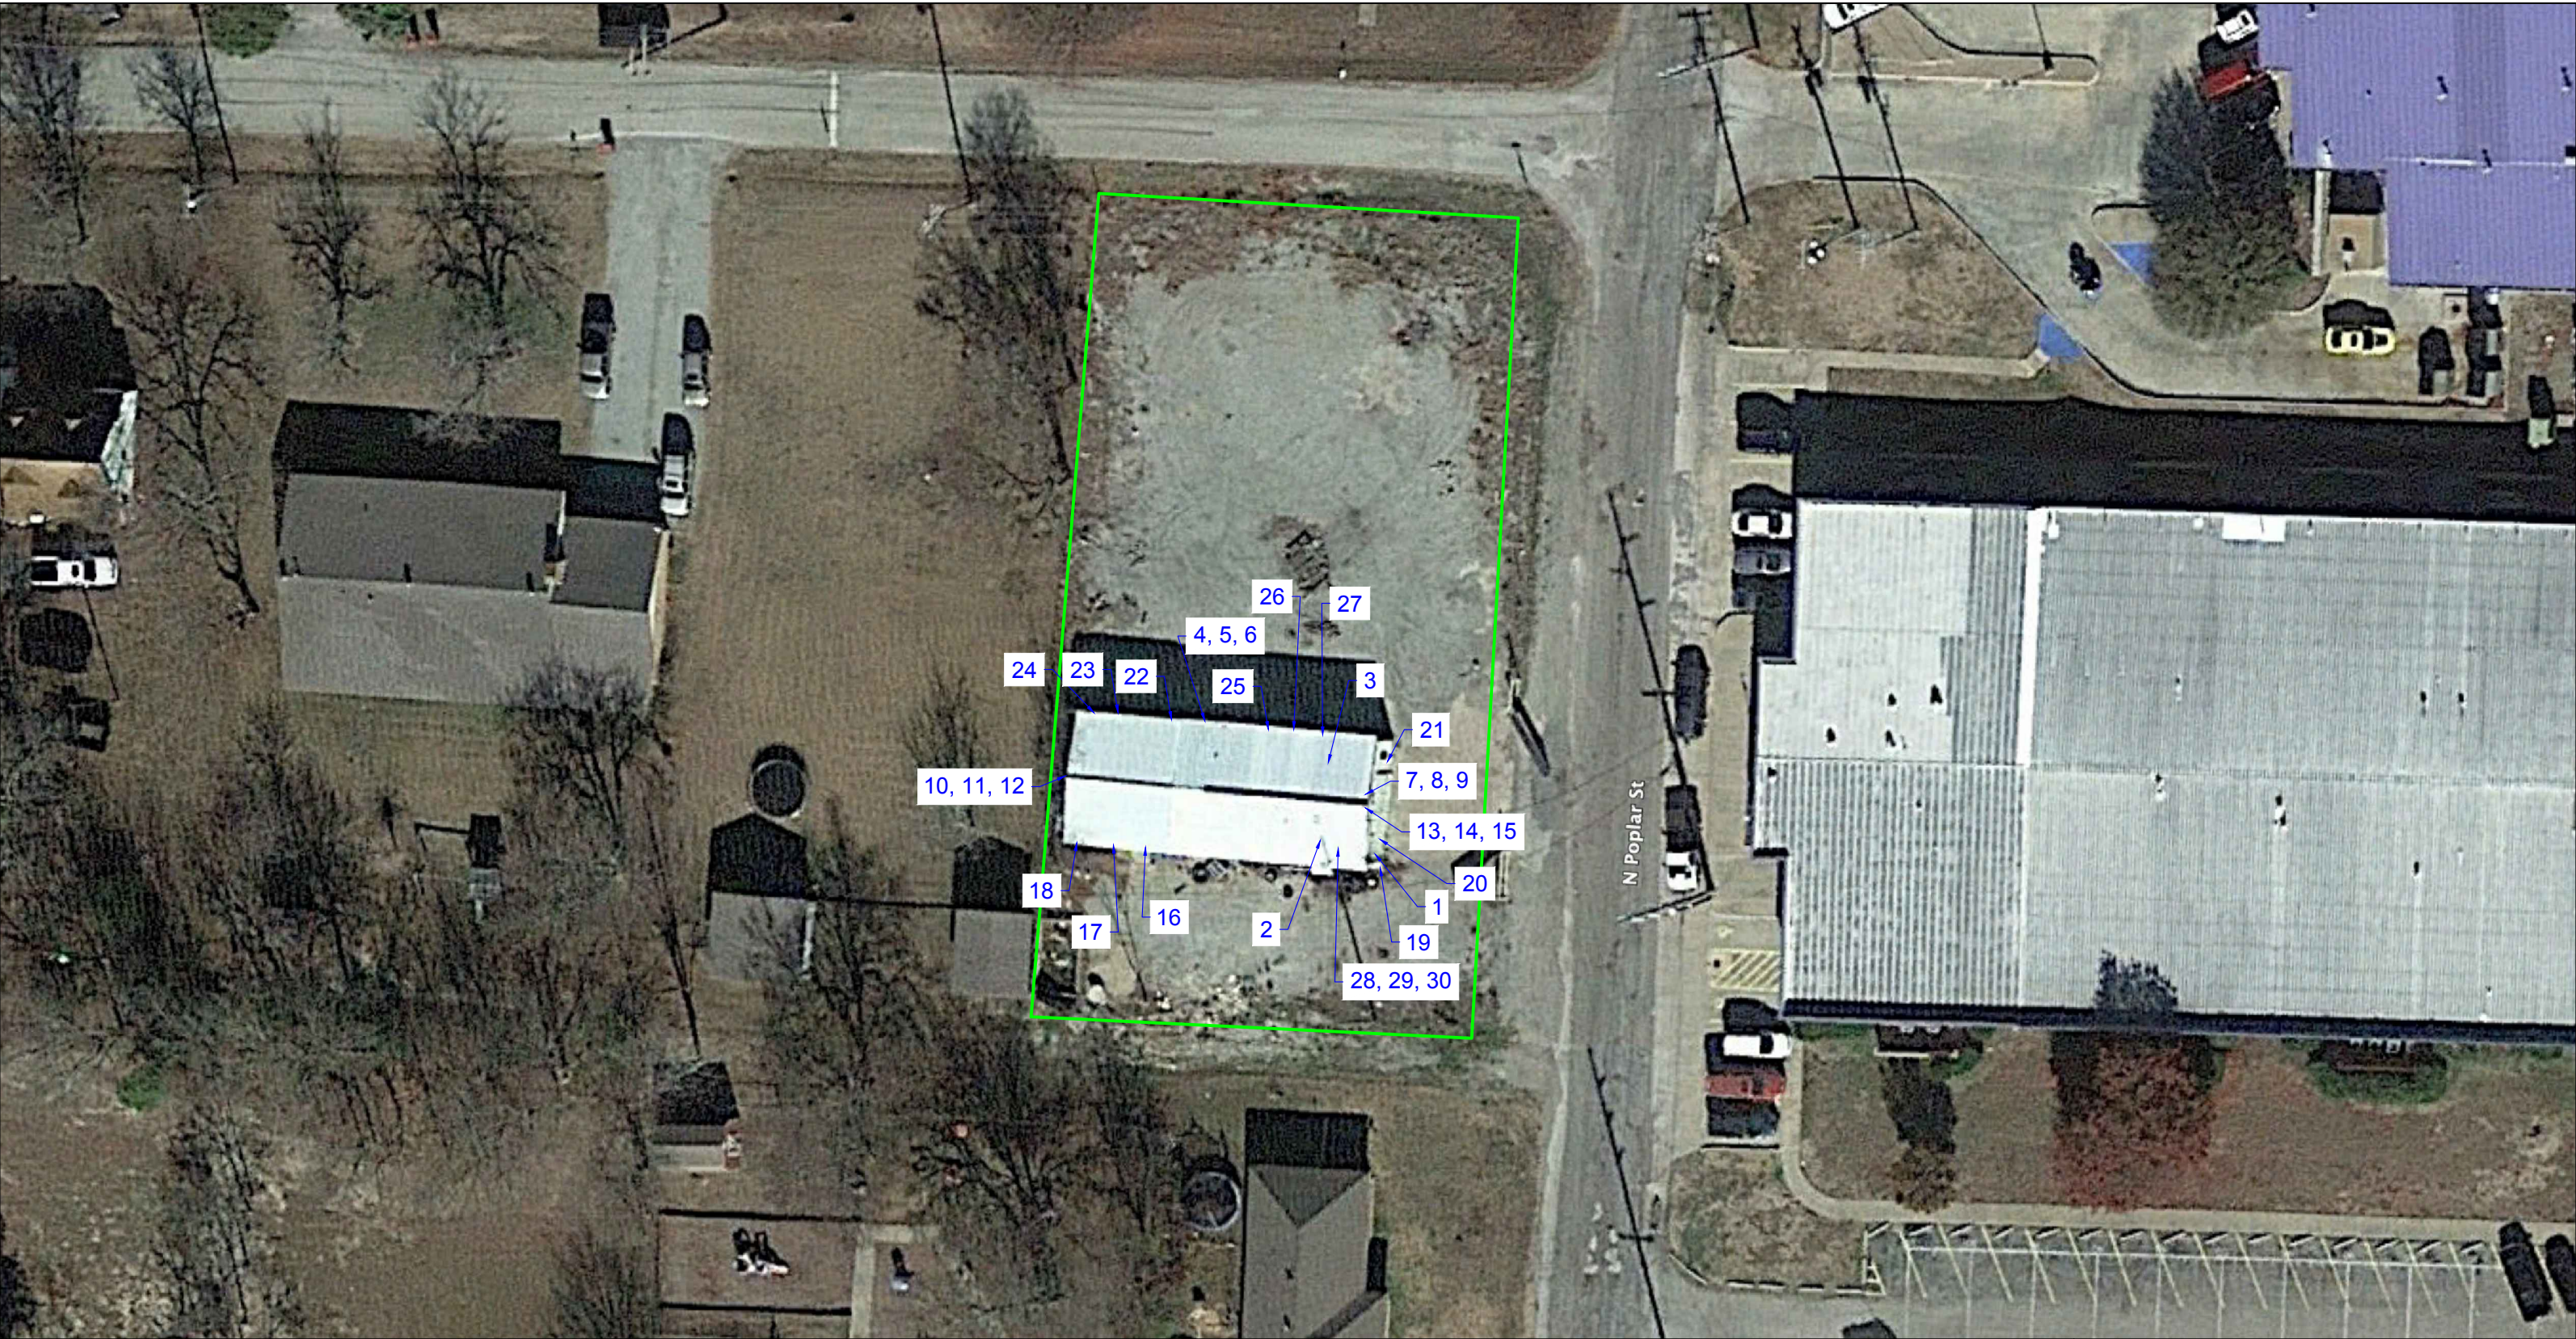
FIGURE 1 - ACM FIGURE

- Roof Sealant/Caulking, Black (8-10%)

HOMOGENEOUS AREA (HA)	LAB SAMPLE NUMBERS	MATERIAL NAME	MATERIAL DESCRIPTION	MATERIAL LOCATION/APPROXIMATE AREA	CONDITION	FRIABLE	ASBESTOS CONTAINING
5	L294233	Roof Sealant	Black Tarry	Main Building Roof Peak/~50 LF (~33 SF)	Fair	No	8-10%
	L294234	Roof Sealant	Black Tarry	Main Building Roof Peak/~50 LF (~33 SF)	Fair	No	8-10%
	L294235	Roof Sealant	Black Tarry	Main Building Roof Peak/~50 LF (~33 SF)	Fair	No	8-10%
